Caples Lake Gage
March 19, 2018

Sand Flat March 6, 2018

Sand Flat

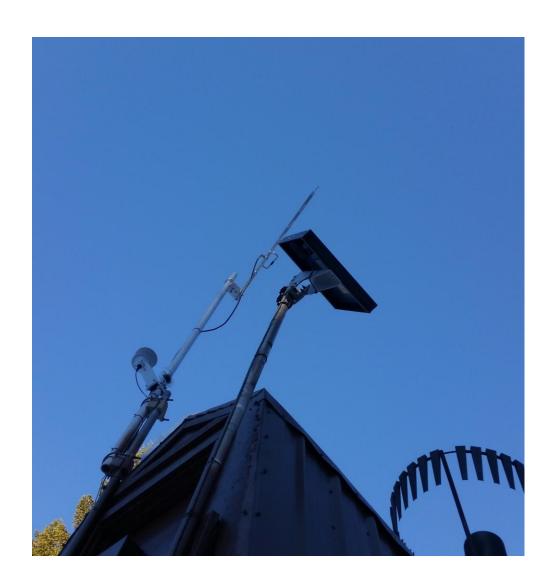
• Began intermittently transmitting on February 18, 2018.

Checked Datalogger and GOES Radio – No problem found

Forgot wattmeter, but had internet access to check NESDIS Field Test
 Power very low or non-existent

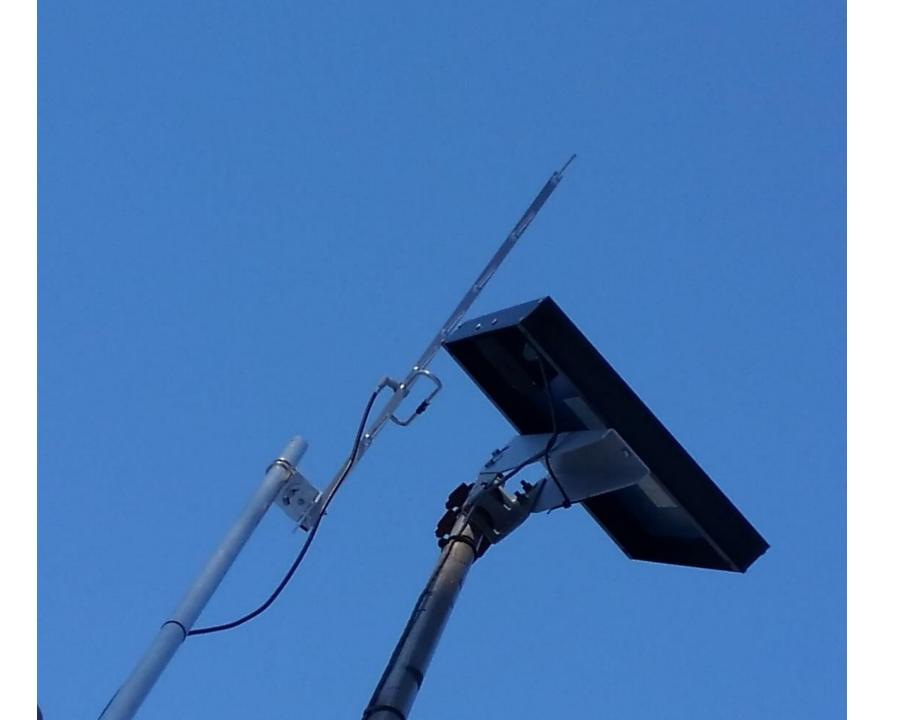
Looked at the antenna cabling and saw this...

Determined the cable was bad due to poor anchoring and would need to be replaced

No ladder available due to snow – Would repair at a later date

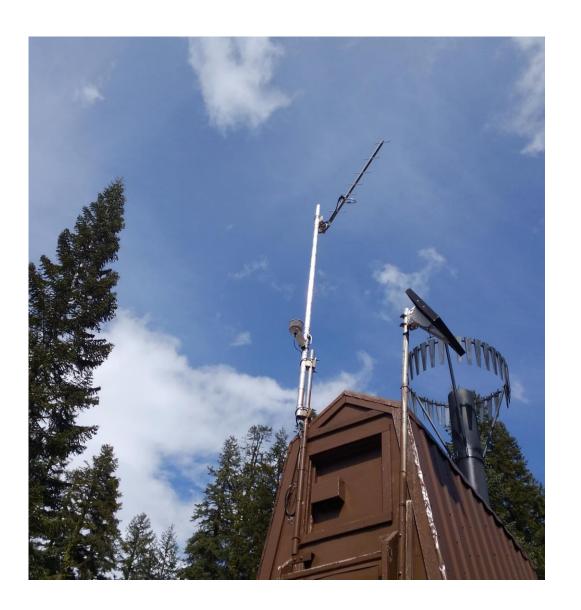
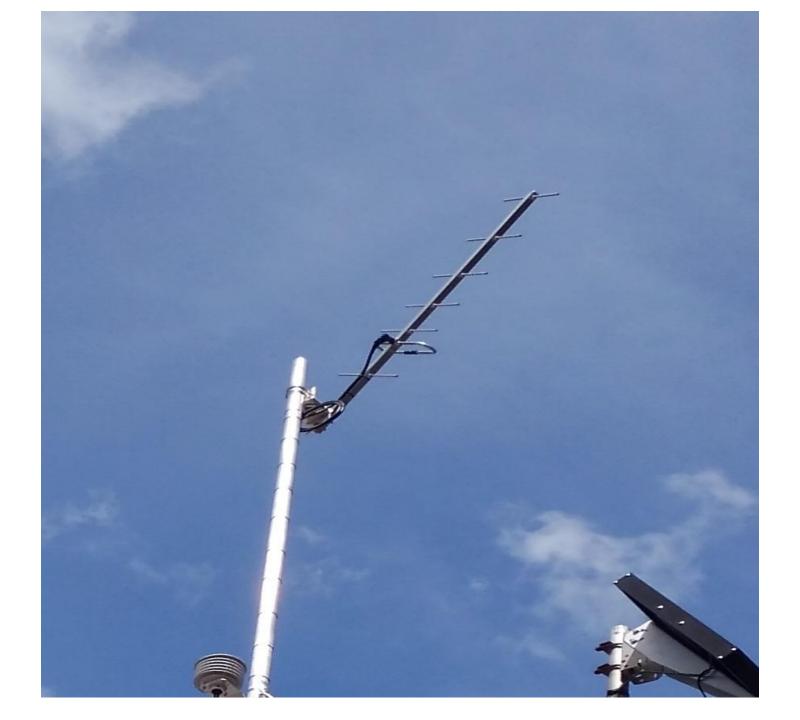
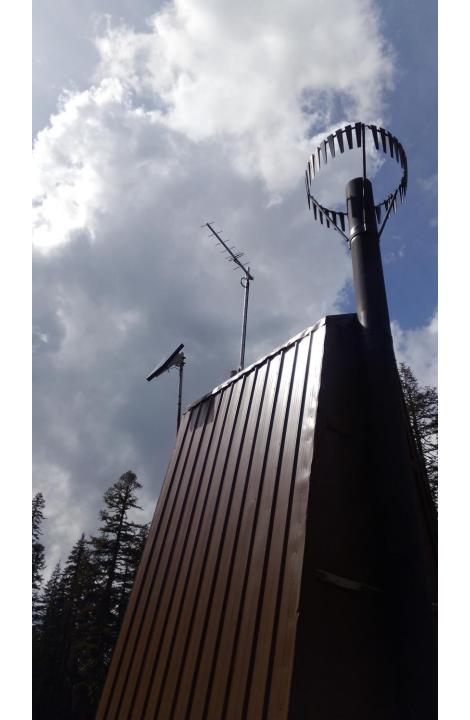
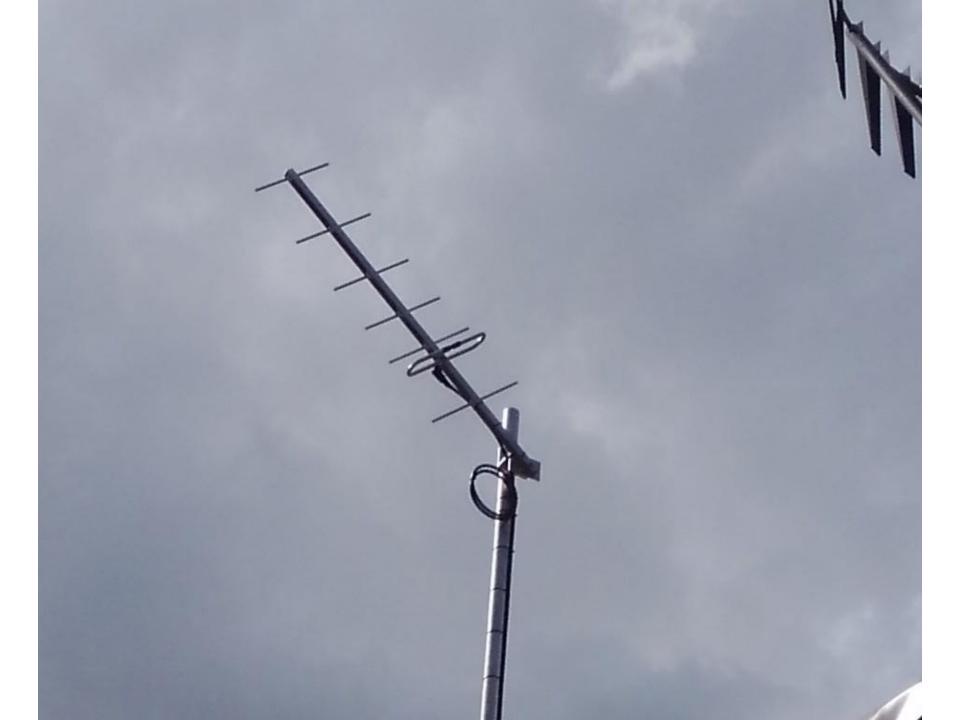
May 30, 2018

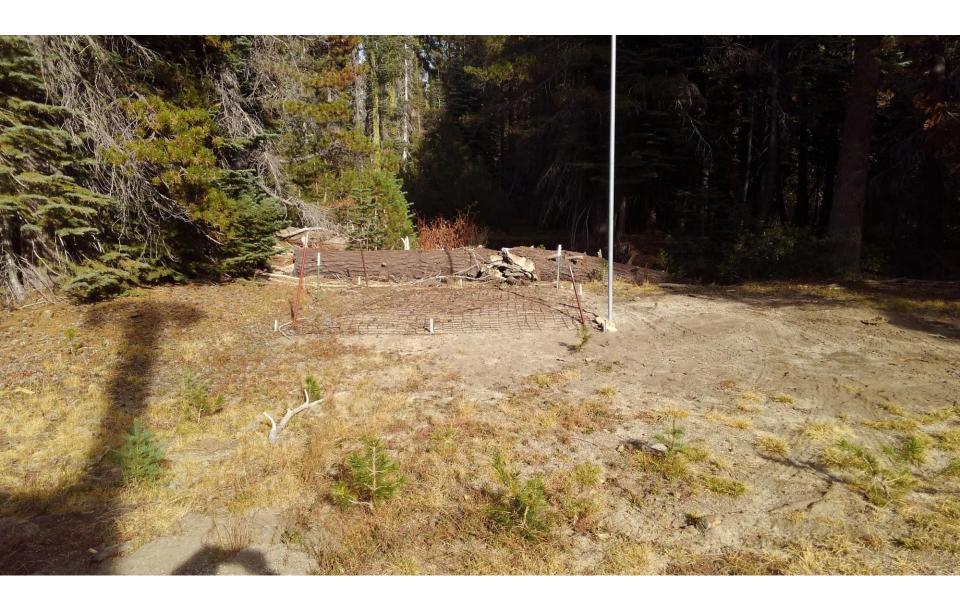
CALIFORNIA COOPERATIVE SNOW SURVEYS

AUTOMATIC SNOW SENSOR

CHM, Chilkoot Meadow

During the winter, instrumentation at this site measures the water content of the snow from which forecasts of your future water supply are made.
